# **Journal Bearing Upgrade to Solve Reliability Issues in an Accessory Gearbox.**

**John K. Whalen, PE**  
**TCE/Turbo Components & Engineering**

**Lorenzo Aburto**  
**Conoco Phillips Alaska**

- Accessory gearbox on gas turbine - generator
- Gas turbine vital for operation of Alpine field on the north slope of Alaska
- Accessory gearbox journal bearings failed on several occasions – brought gas turbine down
- Failures attributed to varying load directions
- Redesigned to replace sleeve bearings with tilting pad journal bearings

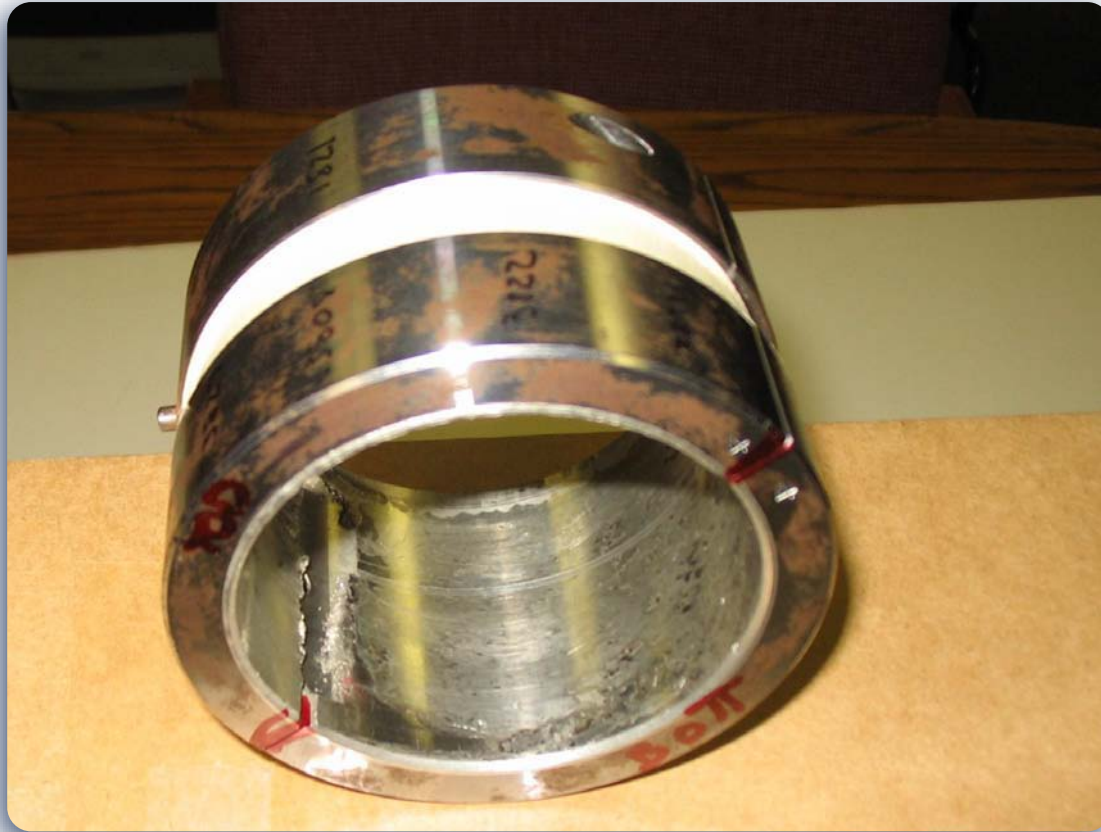
**#4 Journal Bearing- As installed**

- Bearings from shaft 4 and 5 failed
- Shaft 4 experiences severe load angle changes
- Shaft 5 not as severe
- Decided to upgrade to Tilting Pad Journal Bearings
  - Reduce sensitivity to load angles
- Installed and running successfully
